## A Survey of Thatched Buildings in Scotland

Thatch Survey of Scotland  
2014-15

A photographic survey of thatched buildings in Scotland, surveyed between May 2014 and August 2015 by Zoe Herbert (SPAB Scotland Officer), on behalf of the Society for the Protection of Ancient Buildings.

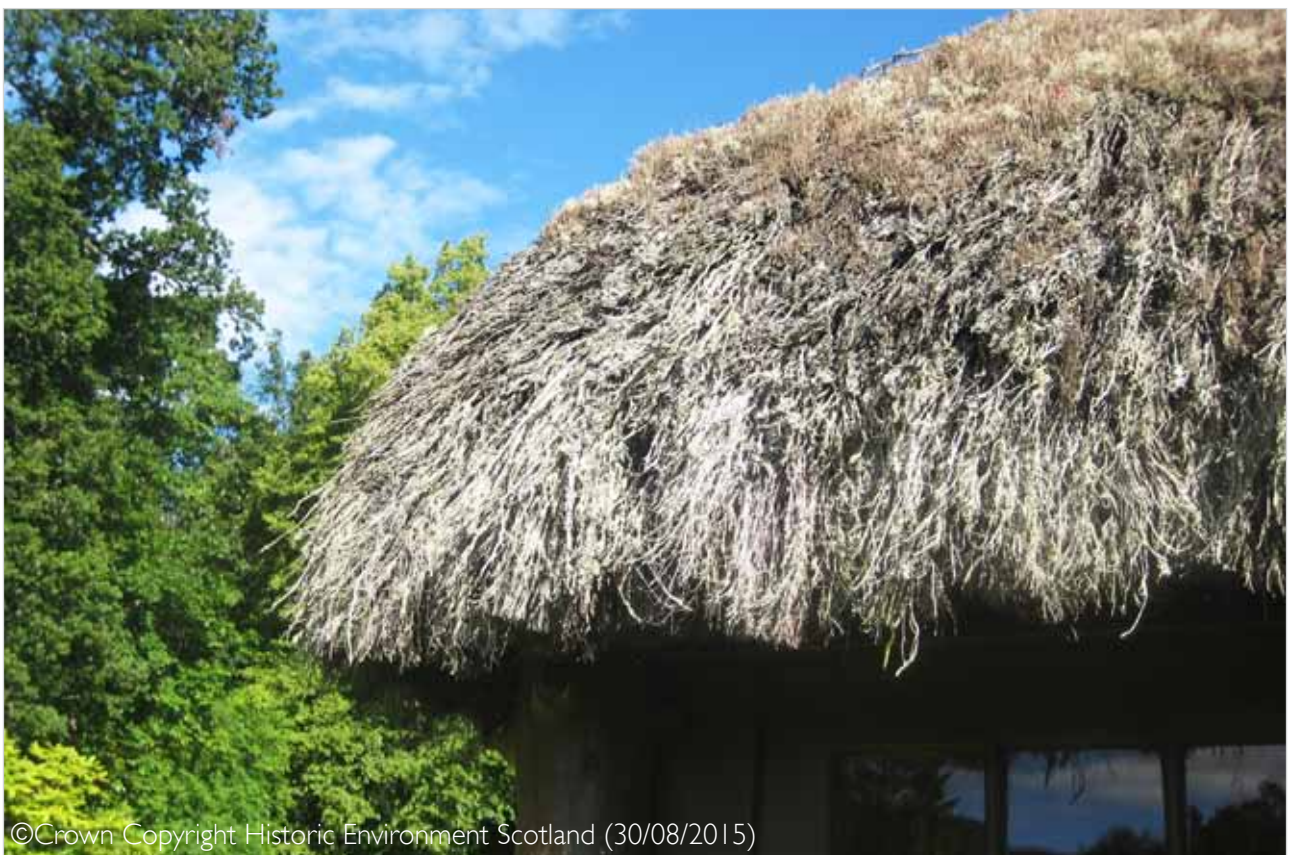
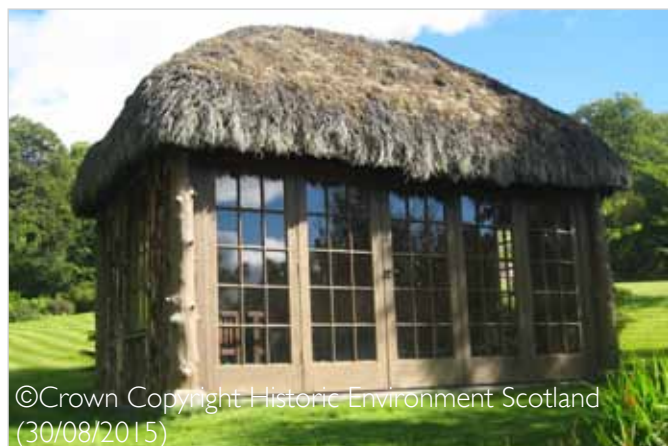
Littlewood Park – Aberdeenshire

Condition: ..... Fair

**Additional Notes:** Small timber summerhouse in the grounds of a private house that was reconstructed circa 1930. The summerhouse, of unknown date, is located to the south of the main house. The heather thatched roof has been left uncovered and is thatched continuously across the ridge. The roof has a large amount of mossy vegetation growth across the surface of the thatch. The building was not visited as part of the survey, however, photographs of it were taken for this purpose by Roger Curtis (Historic Environment Scotland) on 30/08/2015 with permission of the owners.

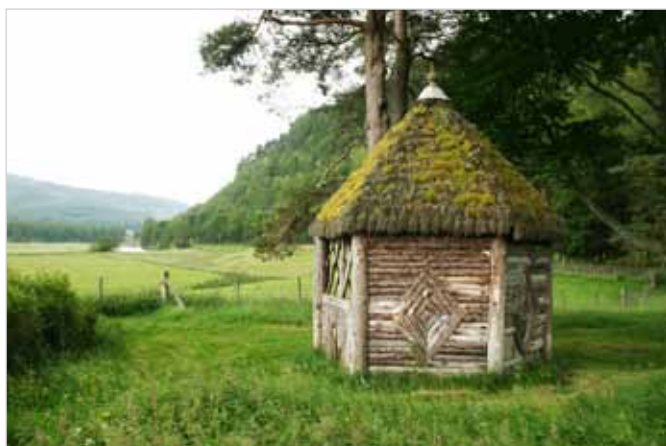
Braemar Castle – Aberdeenshire

Condition: ..... Fair

and the listed building description reads 'round rustic timber summerhouse with conical thatched roof to W. The

with modern timber panelling, and there appears

to be a membrane, which looks like felt, directly

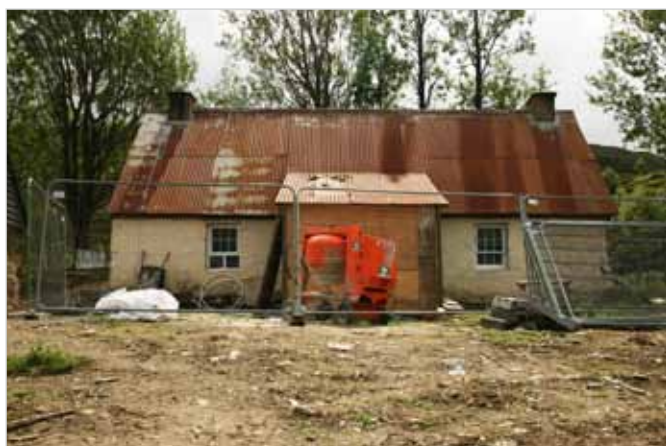
Tomintoul Croft – Aberdeenshire

Condition: ..... Unknown

**Additional Notes:** Early to mid 19th-century crofting cottage with existing heather thatched roof underneath a corrugated iron covering. The heather thatch has been largely undisturbed since the corrugated iron roof covering was put in place at the turn of the 20th century therefore the exact condition of the thatch is unknown. Small sections of the heather are visible from various locations within the interior of the building from behind the timber boarding, and in one location on the exterior at the eaves where the cottage joins the porch extension. The owners recall seeing an old photograph of the cottage before the corrugated iron was installed, that showed

the heather thatch being covered in timber boards.

The thatch has been secured by wires that come down underneath the eaves and attach to the external wall surface by metal pins. The cottage is currently being renovated and turned into a holiday let; however, the thatch and corrugated iron will be retained.

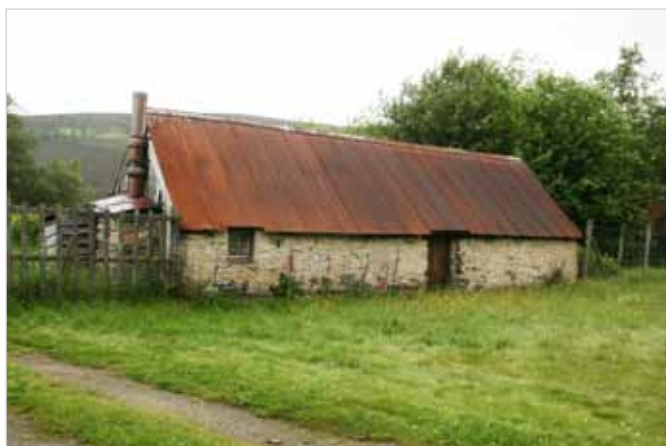
Former Smithy – Aberdeenshire

Address: ..... Former Smithy  
..... Inverey  
..... Mar Estate  
..... Braemar  
Local Council: ..... ABERDEENSHIRE  
Grid Reference: ..... NO 09035 89313  
Date of Visit: ..... 10/07/2015  
Thatch Type: ..... Unknown  
Ridge Type: ..... Unknown  
Condition: ..... Unknown

**Additional Notes:** This mid 19th-century former smithy building is listed as having a corrugated iron roof with thatch insulation. The grid reference shown in the listing for this building is incorrect and identifies a more modern structure to the west of this one (grid reference NO 08981 89302), however the listed building description notes that the building has a 'low rubble lean-to' and 'single metal flue' to the west gable. It also describes a 'small deepset window to far left, single low door near centre' on the south (front) elevation. Whilst internal access could not be gained upon visiting, some thatching material could be seen from underneath the corrugated iron

covering all along the eaves. It is unclear exactly what type of thatch it is; however, it looks to be either heather or bracken. Buildings of similar type and construction next door to this one were found to retain heather thatch underneath their corrugated iron roofs.

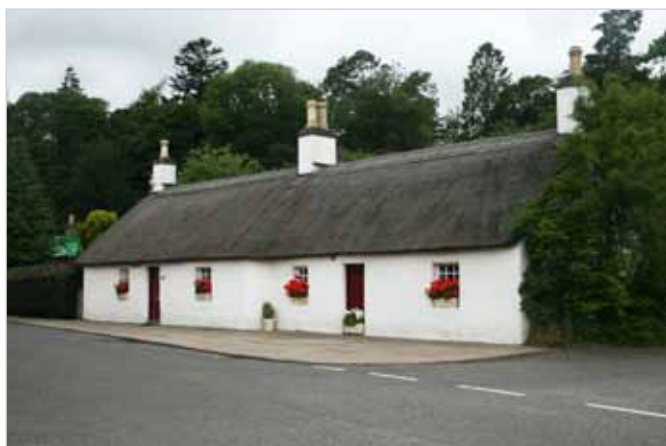
Address: ..... I Main Street

Condition: ..... Good

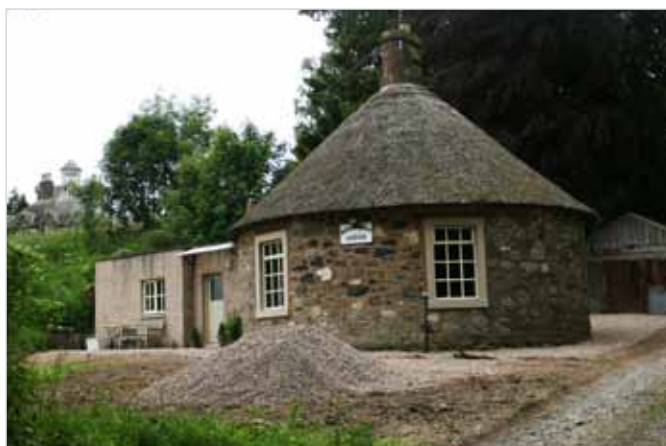
Additional Notes: 'Circa 1888' single-storey, rubble building of circular plan. It has a thatched conical roof with a central stone chimney stack. The roof appears to be thatched in reed and is netted around the top directly underneath the chimney stack for around a foot in width. The rest of the thatch has been left uncovered. There is a small amount of mossy vegetation growth across the surface of the thatch and a few dislodged pieces of reed in places. Modern single-storey extension to the building on the north-west side, which is not thatched.

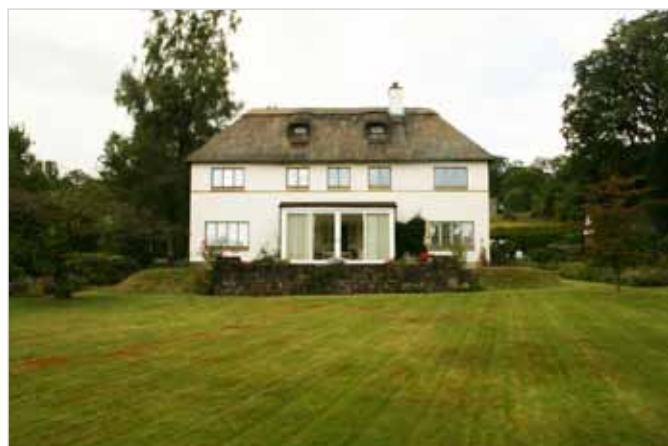
Ardlarich – Argyll & Bute

to stop vegetation growth. The thatchers also

repaired minor damage caused by birds and also

was in poor condition. Currently, there are a few

small patches of mossy vegetation growth across

the surface of the thatch.

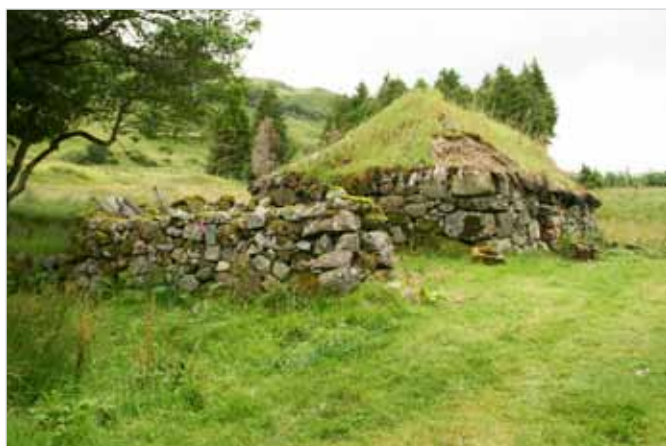
Building G – Argyll & Bute

**Additional Notes:** Reconstruction cottar's house, part of the Auchindrain open-air museum of a traditional Scottish Highland farm township. The building is part of a group listing with 22 other structures. Historic maps have shown a building on this site in both 1789 and 1871, however by 1946 the building on this site was abandoned and roofless. In the early 1980s, the building was excavated and was then ultimately reconstructed to simulate a cottar's house from the early 19th century. The building was given a cruck-framed roof that was covered in bracken thatch. Since this time, the building has been deliberately left unused and abandoned, and the thatch

left to deteriorate, as apparently a township would have always had some unoccupied buildings. The bracken thatch, which appears to have a continuous bracken ridge, is in a poor condition and is heavily overgrown with grassy vegetation.

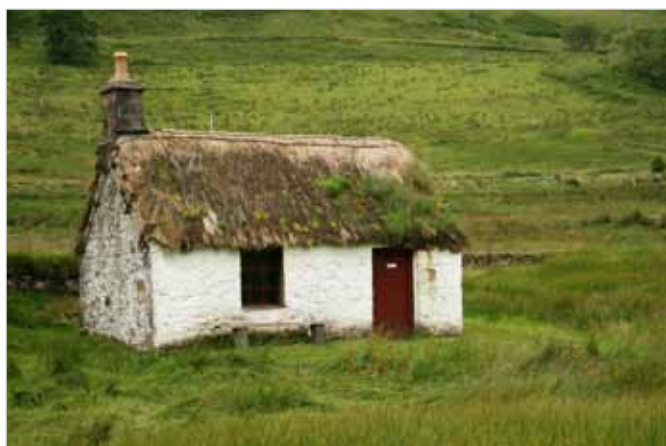
Building M, Bell a'Phuill's House – Argyll & Bute

**Additional Notes:** Small traditional cottage, now part of the Auchindrain open-air museum of a traditional Scottish Highland farm township. The building is part of a group listing with 22 other structures all from the late 18th and 19th centuries. Bell a'Phuill's House, as it is now known, was occupied by 1841 as a dwelling. It was lived in until the death of Isabella McCallum (Bell a'Phuill) in 1915 but thereafter fell into disuse, and by 1946 was roofless and derelict. The building was repaired and re-roofed in 1975, and has been regularly re-thatched since. It is thatched in rush, as this material grows in abundance around the site, and was last re-thatched in 2011, receiving

a top-dressing in 2012. The ridge appears to have been thatched more recently than the rest of the roof, which has an amount of mossy and grassy vegetation growth across the surface of the thatch. The ridge has been scobed with two horizontal lines of thin branch.

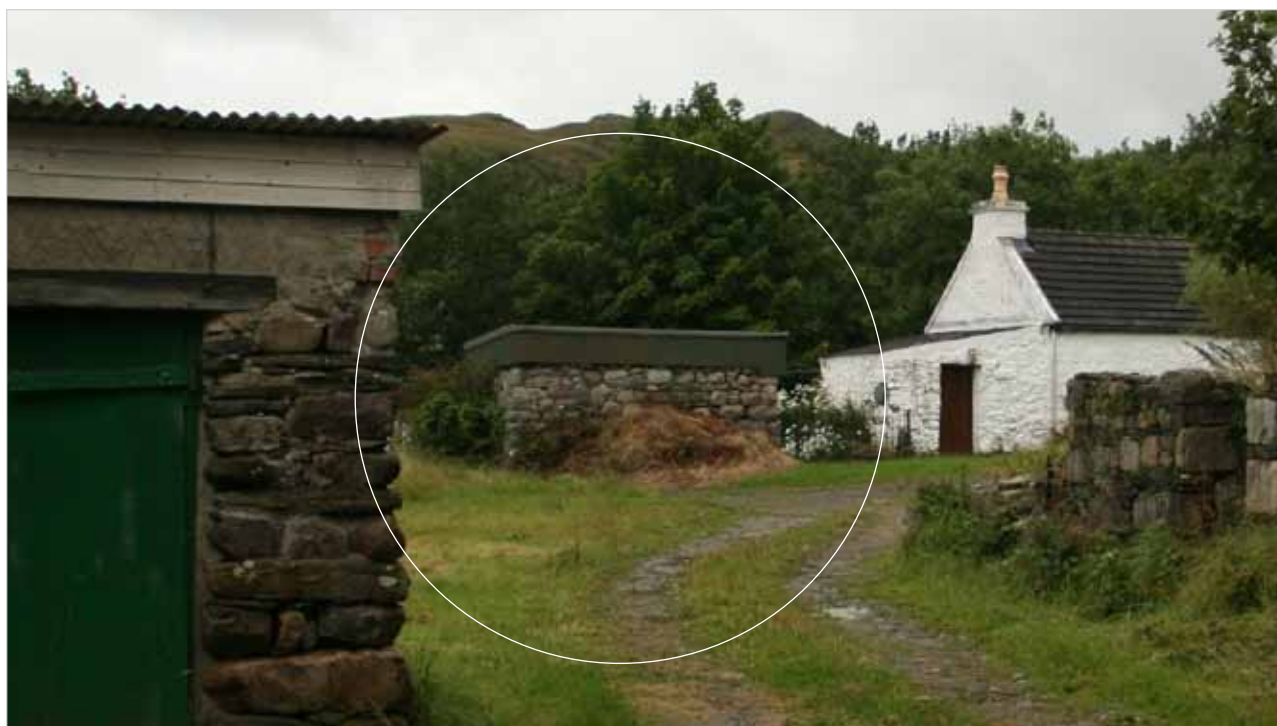
Address: ..... Keils Cottage

**Additional Notes:** ..... The former byre under the group listing with Keils Cottage was formerly thatched. The listed building description reads '*Byre to east, now partially ruined. Single bay remains. Dry-stone walls, dressed quoins remain at north. Infill wall on ruined gable end with remnants of lum. Very rough roof trusses, thatched roof.*' What is left of the building has been re-roofed and no thatch remains. It is unclear whether the building is still being used in any way.

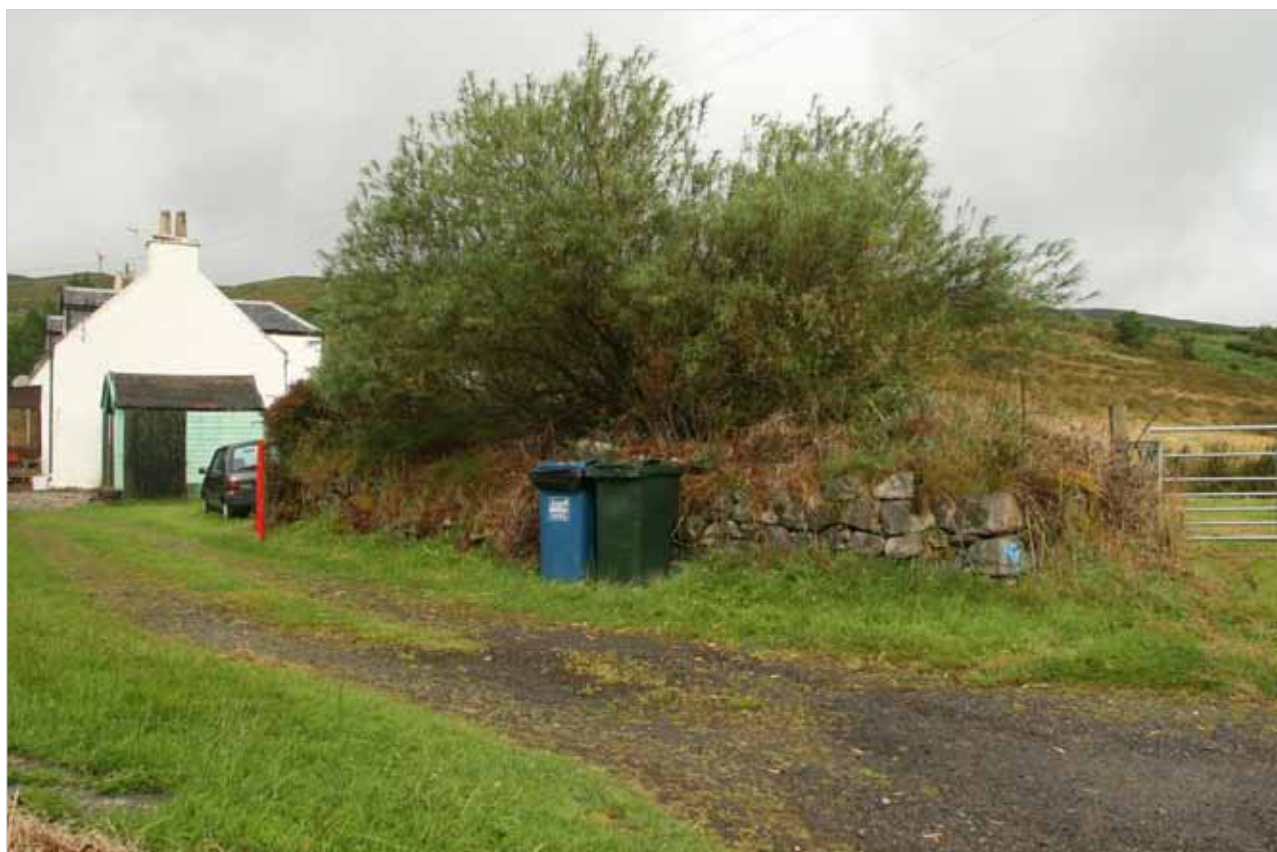
Address: .....Store/Hut East of A. Keith

Additional Notes: .....Listed building description reads '*Probably early 19th century. Single cell store with entrance on gable end. Dry-stone walls. Thatched roof.*' The building is now a roofless ruin and is heavily overgrown with vegetation. The building's shell only survives up to a few feet in height and none of the roof structure remains.

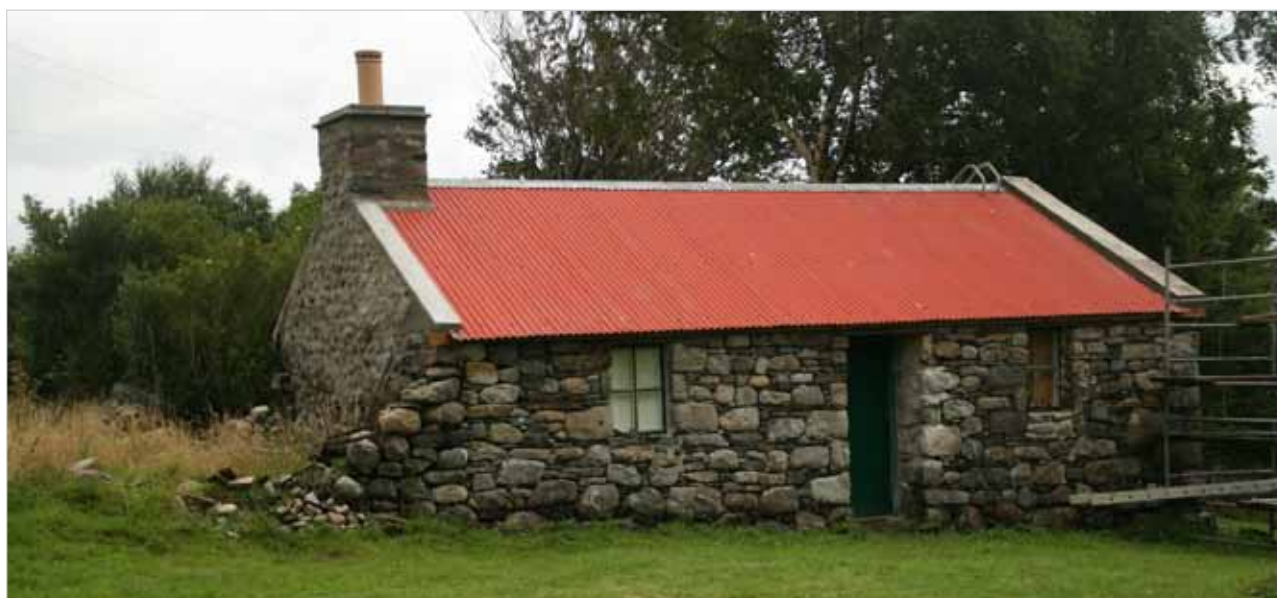
Address: ..... Disused Cottage

**Additional Notes:** ..... The building was added to the Buildings at Risk Register in 2010 (BAR reference number 4601), and was last inspected by BAR in 2012. In 2009 the building was recorded as 'a ruined shell in the slow process of collapse', however, it was moved to status 'Restoration in Progress' by 2012 after having 'partial wallhead consolidation and the insertion of a new door and window'. Since then, the building has been restored further and a corrugated iron roof has been installed. The building is now weather tight and is being used as a store and workshop by the owner. The listing description for the building, which states that it has a thatched roof, should be updated accordingly. ....

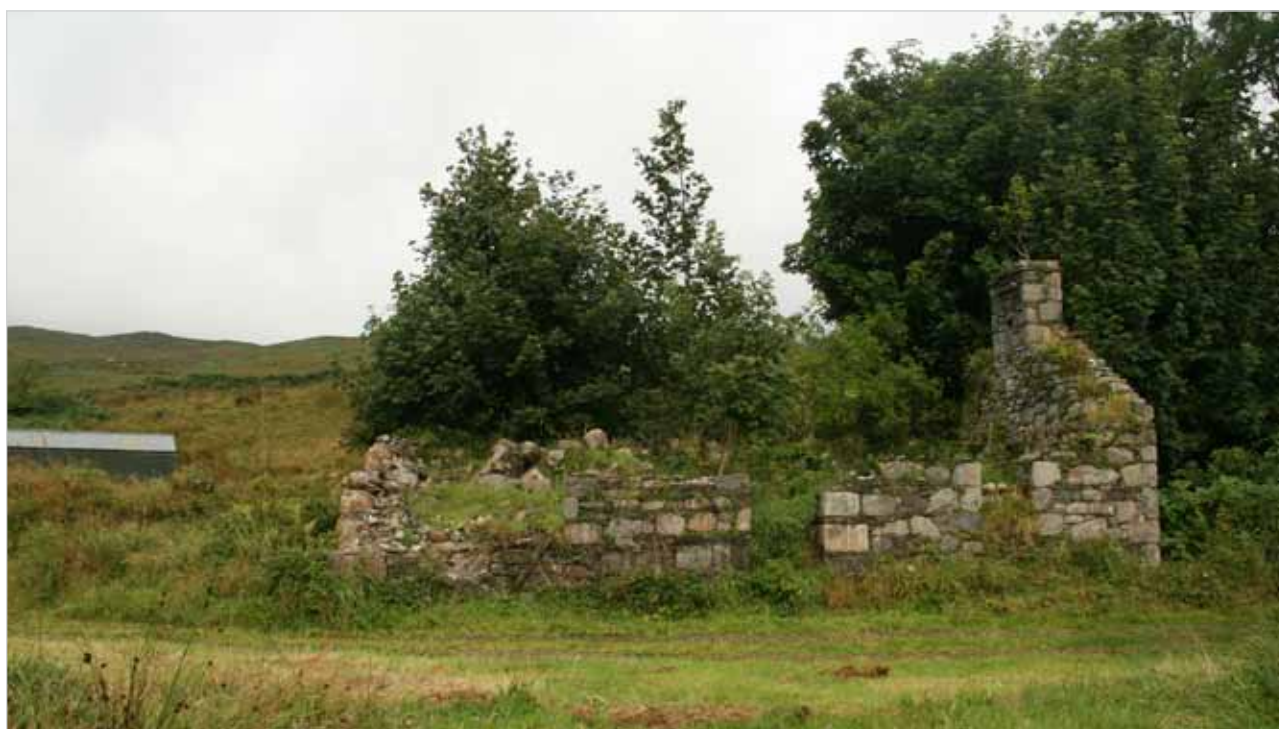
Address: ..... Disused Cottage

**Additional Notes:** ..... Early 19th-century single-storey cottage, which has been on the Buildings at Risk (BAR) Register since 2010 (BAR reference number 4603). BAR inspection notes from 2009 and 2012 describe the building as 'a roofless shell'. Comparing images from BAR inspections in 2012 to the current condition, the building has deteriorated even further, with the south gable and chimney stack having collapsed. The listing description for the building, which states that it has a thatched roof, should be updated accordingly.

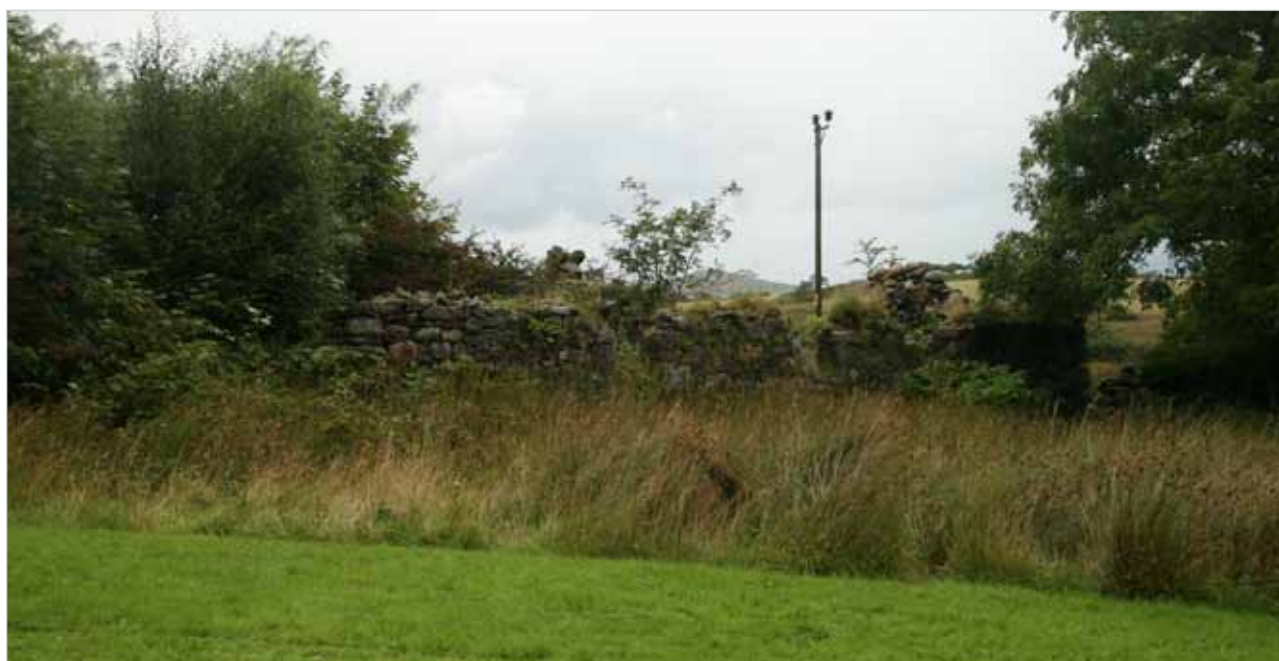
Address: ..... Thatched Byre

Additional Notes: ..... The listed building description reads '19th century byre, half now ruined. Rubble-built with roughly dressed quoins and jambs. Entrance with window to west on south elevation. Surviving part thatched'.

..... The building is now a complete ruin and none of the roof structure or thatch remains. The building has been on the Buildings at Risk Register since 2010 (BAR reference number 4602) and upon inspection in 2009, BAR noted that 'External inspection finds the formerly thatched building now in an advanced state of collapse', with no significant changes recorded in 2012.

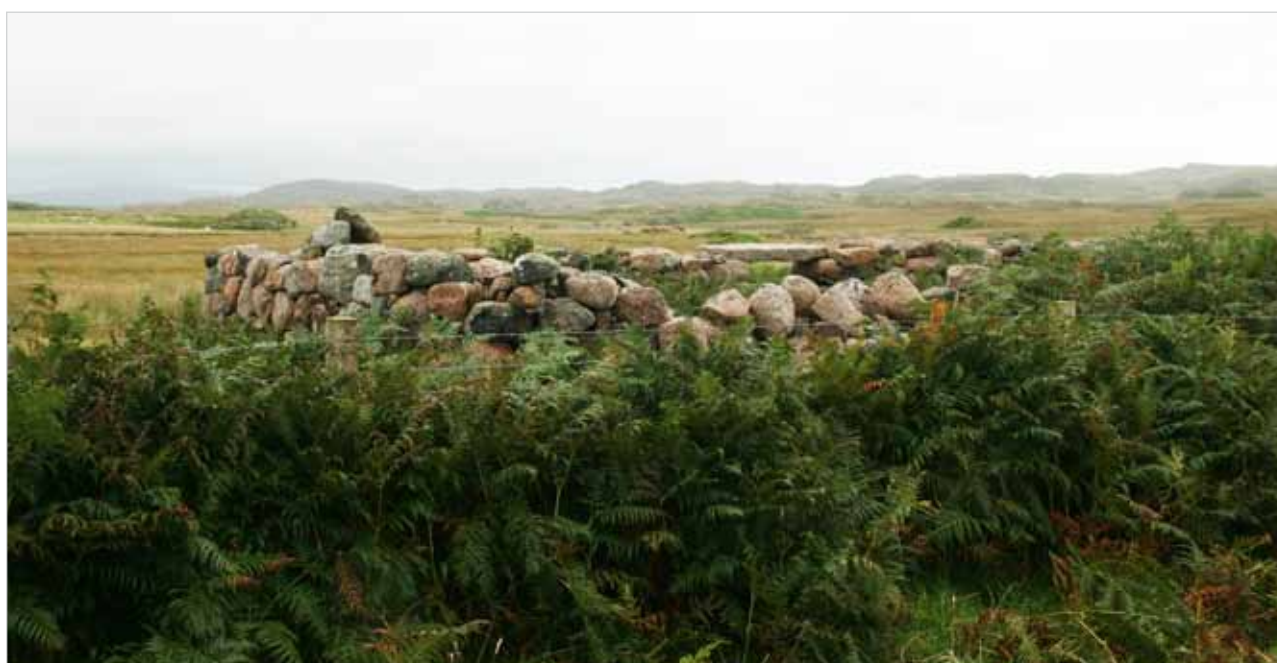
Address: ..... Gate Cottage

**Additional Notes:** ..... The listed building description reads 'Small Highland cottage (Skye type). Straw-thatched roof with piended ends. Chimney-vent at W end', however, the listing notes simply read 'derelict'. The building is now a ruin, the rubble walls survive up to around the height of the door lintel and the whole site is overgrown with vegetation. Canmore records from a visit to the building in 1980 note that the 'Thatched cottar's house [...] probably dates from the first half of the 19th century; it was occupied until about 1968, but has deteriorated rapidly since that date'.

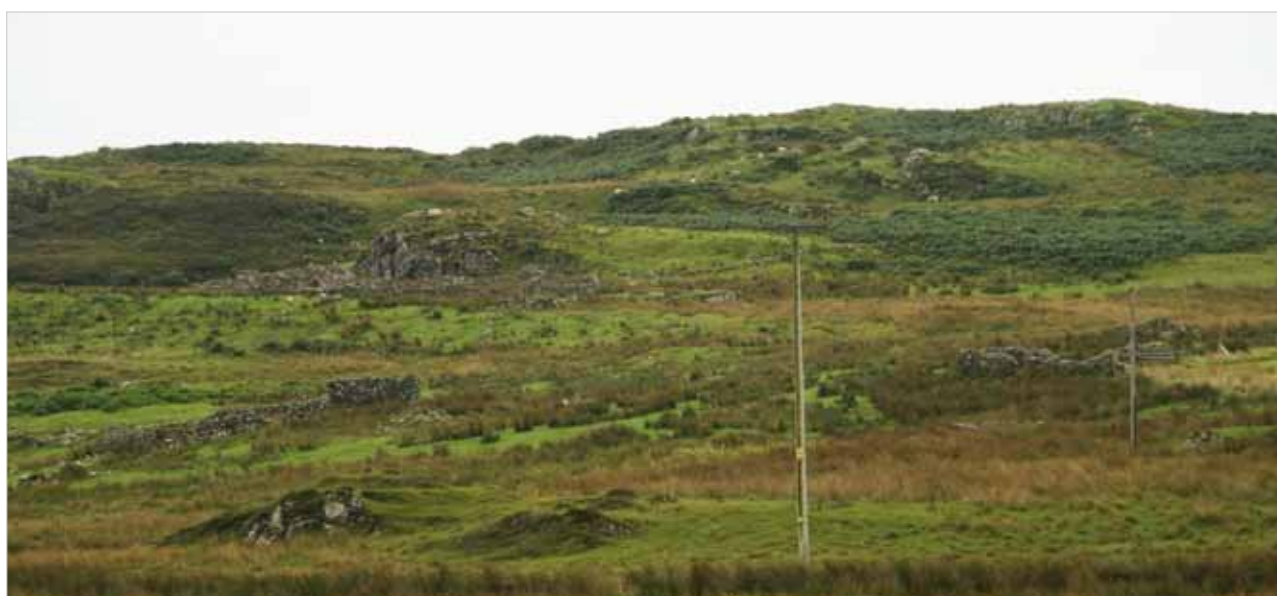
Address: ..... Braigh Croft Cottage and Byre

Additional Notes: ..... Due to the highly ruinous nature of the site and the adjacent ruined buildings, it is unclear exactly which building footprint relates to this building, however, no thatch remains on the site. The building was surveyed in the Argyll & Bute District Council Thatched Buildings Survey of Tiree, Coll & Mull in 1985 (Entry Number 26, named 'Bra Cottage'). Here it is noted as being '*The last thatched building left on Mull*', and at the time was thatched in rushes with a muran grass ridge and a turf underlay. The materials were apparently cut from the Island and the building was last re-thatched by the owner six years prior (circa 1979). The listing description for the building, which states that it has a thatched roof, should be updated accordingly.

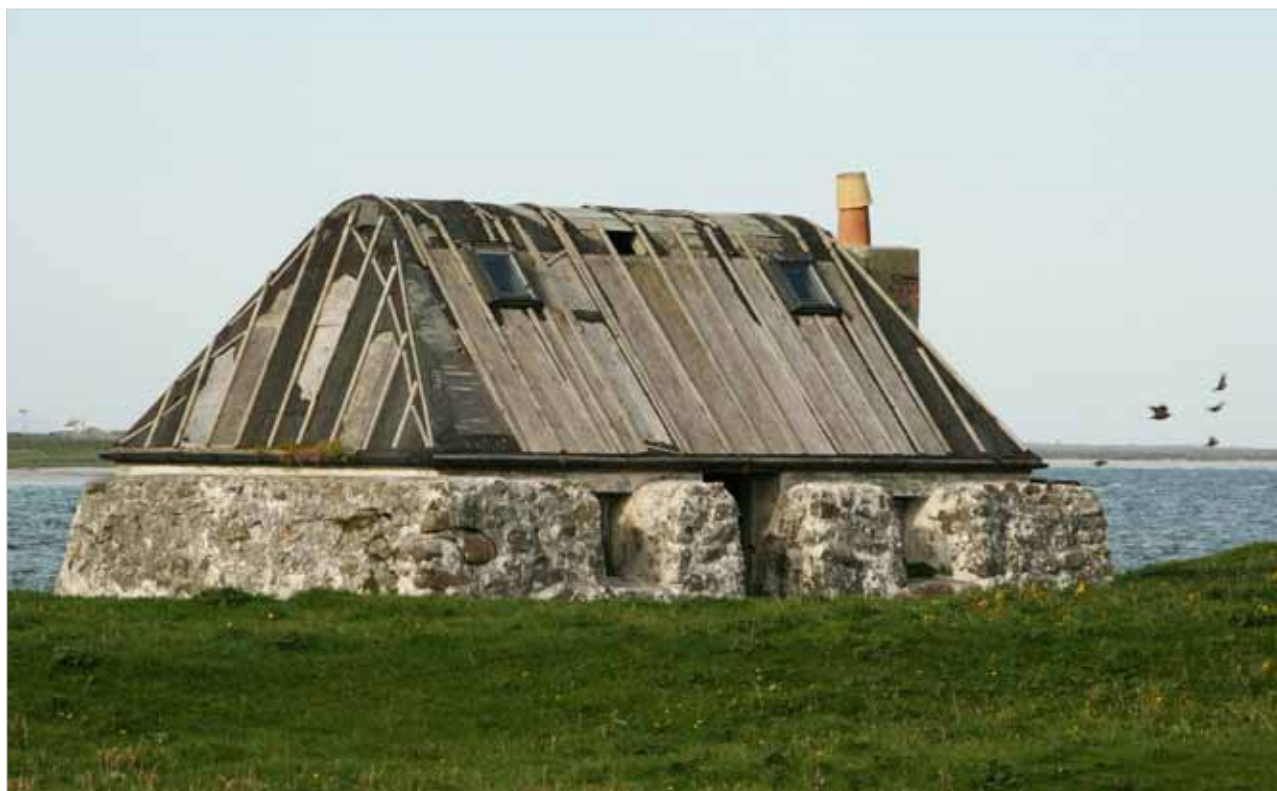
**Additional Notes:** ..... The listing description for the property reads '19th century traditional single storey 3-bay cottage with centre door; rubble-built, wide eaves ("tobhta"), 1 gable end stack; piended tarred felt roof with small skylight'. It does not state whether the building was originally thatched, although this is probable. The building is currently on the Buildings at Risk Register (BAR reference number 3881).

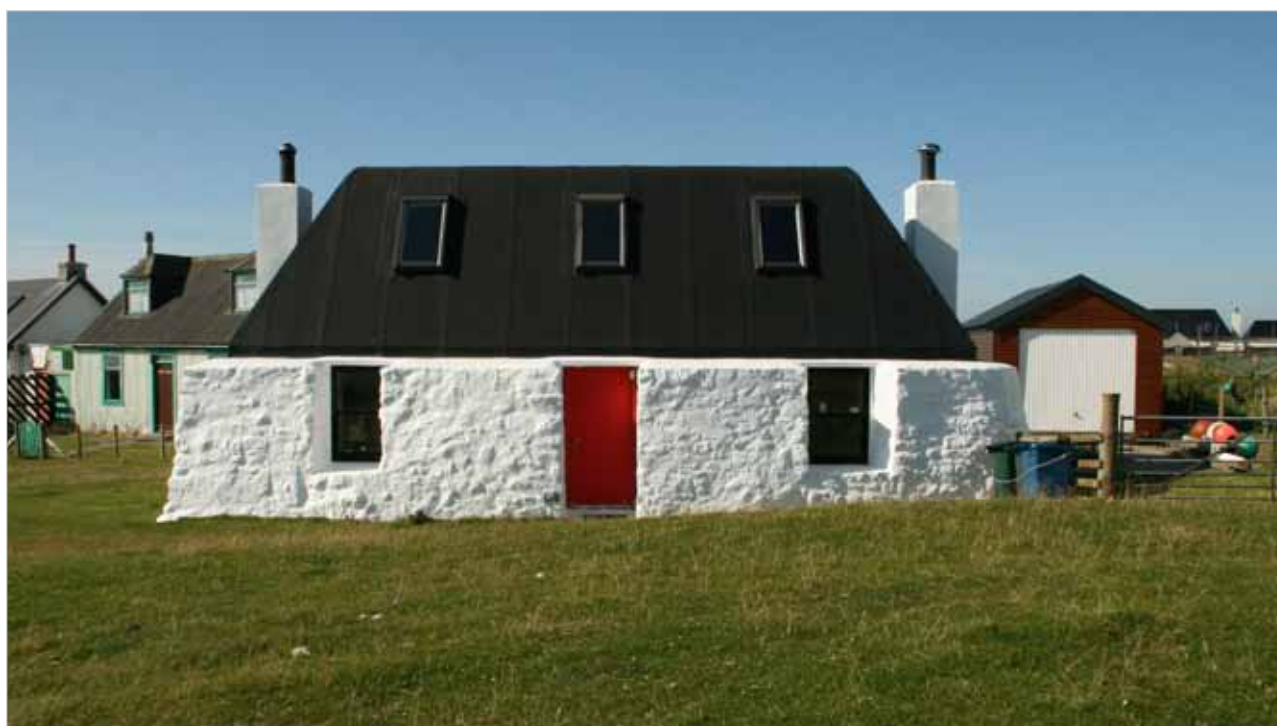
Address: ..... Dun Beag Cottage

**Additional Notes:** ..... 18th-century cottage, listed as having a '*piended thatched roof*'. The building is no longer thatched, and now has a tar felt roof with sky lights. This building is entry number 21 in the Argyll & Bute District Council Thatched Buildings Survey of 1985, where it is reported to have been '*long derelict and roof has fallen in*'. According to the 1985 survey it was last occupied in 1969 and maintenance to the roof had ceased during the 1970s. The listing description should be updated accordingly.

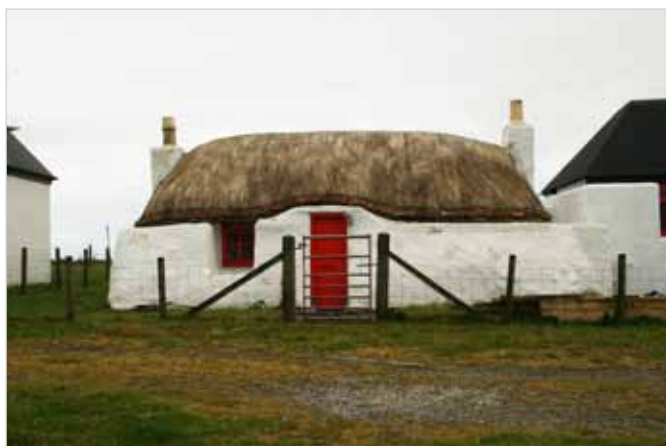
Pierview Cottage – Argyll & Bute

The roof is currently thatched in marram with a continuous marram-thatched ridge. The entire roof has been netted including across the ridge, which has been weighted down using a string of bricks and thin ropes around the roof just above the wallheads, including above openings but not around the chimney stacks. The netting has been weighted around the chimney stacks with planks of wood, held down by breeze blocks and thin ropes, to provide additional protection at this slightly more vulnerable junction of the thatch. A wooden board has been

installed above the window opening on the front elevation only.

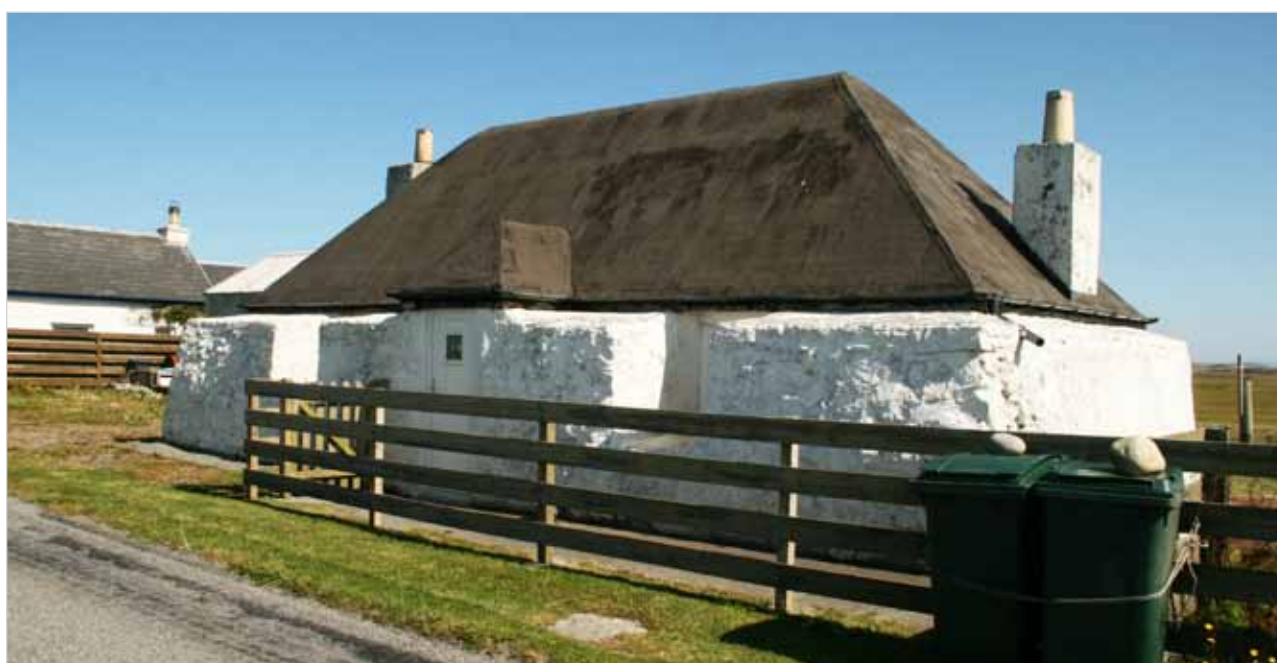
Address: ..... Kenovay Cottage

**Additional Notes:** ..... The building at the location associated with the listing now has a black top roof and is no longer thatched. It has also had a modern extension added to the back. Its listing description reads '*19th century traditional single storey 3 bay cottage: rubble, partially cemented, white-washed: wide eaves ("tobhta"); gable end stacks: piended thatched roof*'. The building is noted in the listing as being entry 7 in the Argyll & Bute District Council Thatched Buildings Survey (1985), however this information appears to be incorrect (the property at 3 Kilmoluaig is entry 7).

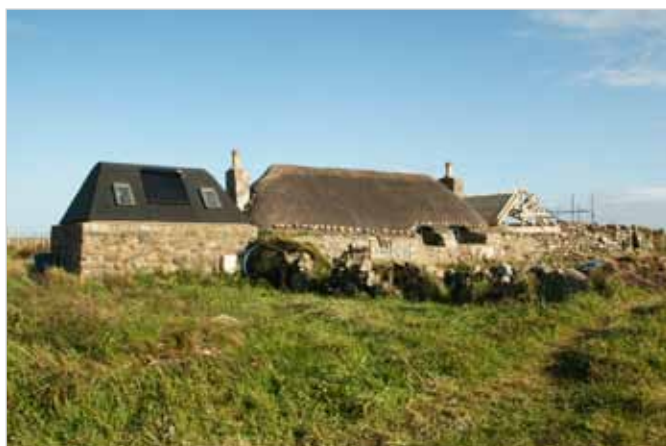
Cnoc Bhiosta – Argyll & Bute

**Additional Notes:** ..... This early 19th-century cottage is listed as being flanked by byre/barn at each gable end and having '*piended thatched roofs to cottage and one barn; tarred felt to second*'. The barn to the north has a felt roof, whilst the barn to the south is in a ruinous condition, though the owner is in the process of restoring the south barn and building a new roof. The main cottage remains thatched. The whole roof, including across the ridge, has been netted and weighted down using thin ropes and stones. The stone weights run around the entire circumference of the building just above the wallhead, openings and around the chimney stacks at either end.

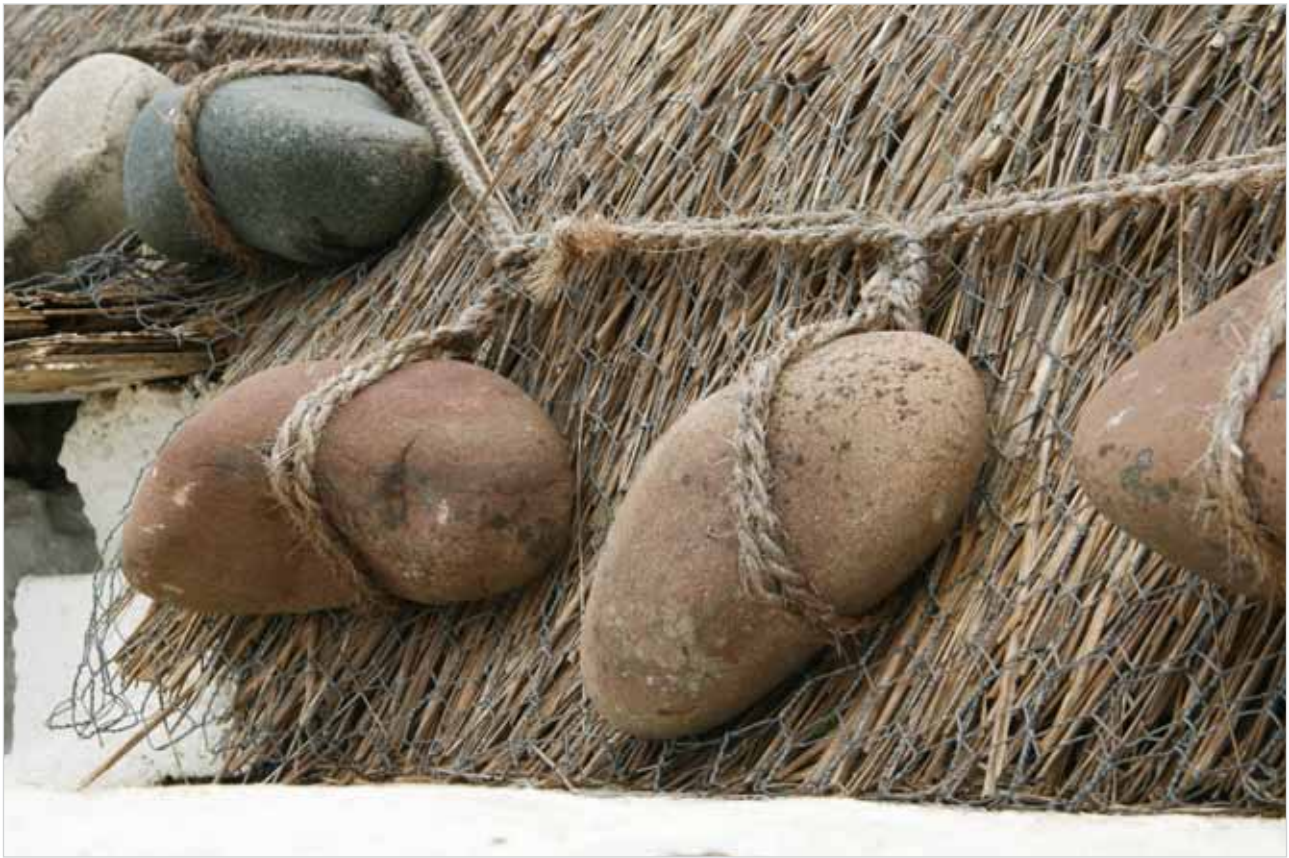
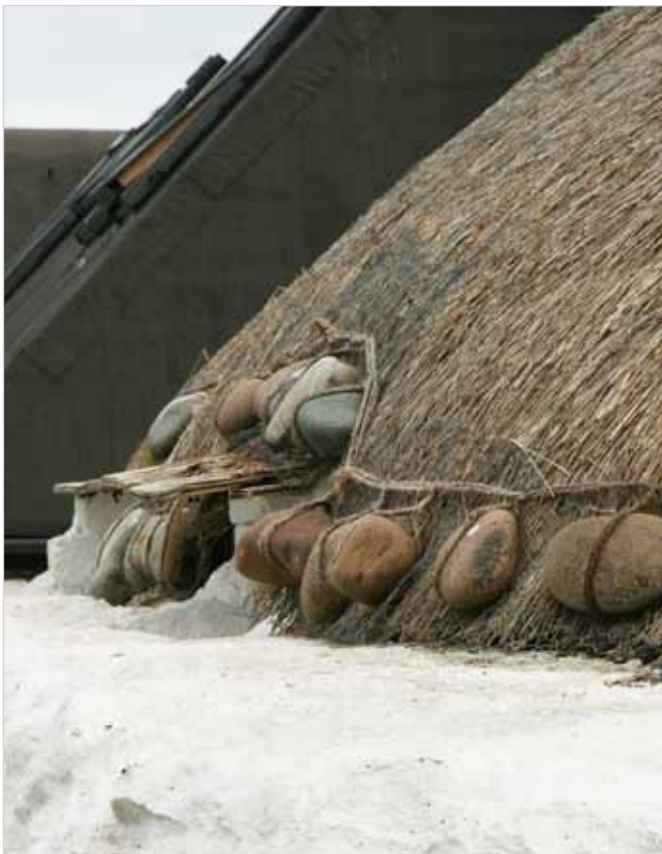
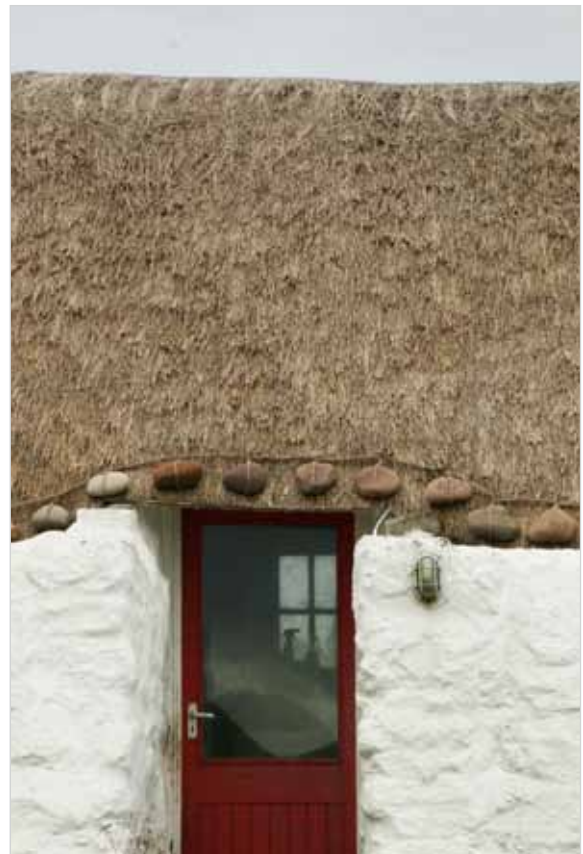
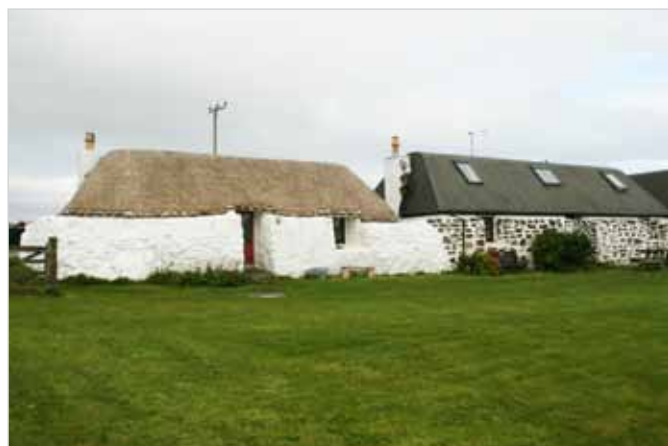
3 Kilmoluaig – Argyll & Bute

**Additional Notes:** From what can be understood of the listing description and accompanying notes, there were, at the time of listing in 1981, two thatched roofs at this site. The 19th-century cottage is listed as having 'piended thatched roofs', and the listing notes read '*original dwelling renovated and re-roofed in substantially traditional fashion in 1981. Adjoining byre demolished and now thatched dwelling in substantially traditional style built on site.*' Exactly which other roof was thatched at this time is unclear; however, now only the roof to the south cottage is thatched, in marram with a continuous marram ridge. The entire roof has been netted, which has

been weighted down with stones and thin ropes just above the wallhead, openings and around the chimney stack to the south gable. Wooden boards have been installed above the door and window openings.
